ATTACK HELICOPTER EVALUATION AH-56A
CHEYENNE COMPOUND HELICOPTER

Army Aviation Systems Test Activity
Edwards Air Force Base, California

June 1972

FINAL REPORT

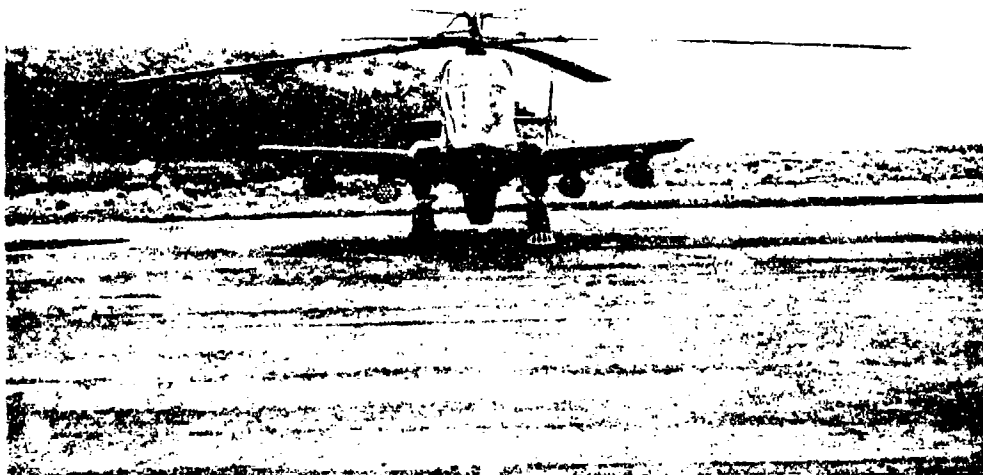
PHOTO 1. FRONT VIEW

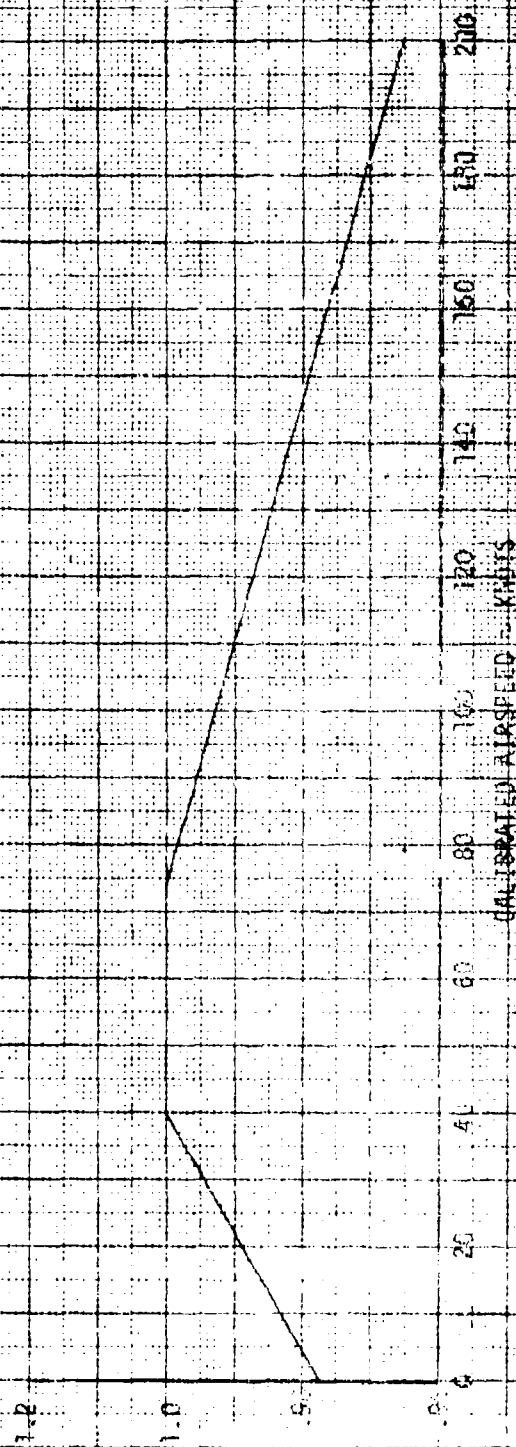
FIGURE 5
ENGINE INLET CHARACTERISTICS

NOTES: 1) DATA PROVIDED BY LOCKHEED CALIFORNIA COMPANY
2) NO AIR FILTERS
3) FOD SCREEN INSTALLED
4) SEALED PLENUM

COMPRESSOR INLET TOTAL PRESSURE
INLET STATIC PRESSURE

4H-56A USA S/N 65-8834
T64-GE-716
